Follow-Up of Newport Kappa Diffractometer Incident at 7ID-C

Don Walko, MHATT-CAT
Sector 7, XOR, APS, ANL
d-walko@anl.gov

Presentation for APS Technical Working Group, 1/22/04

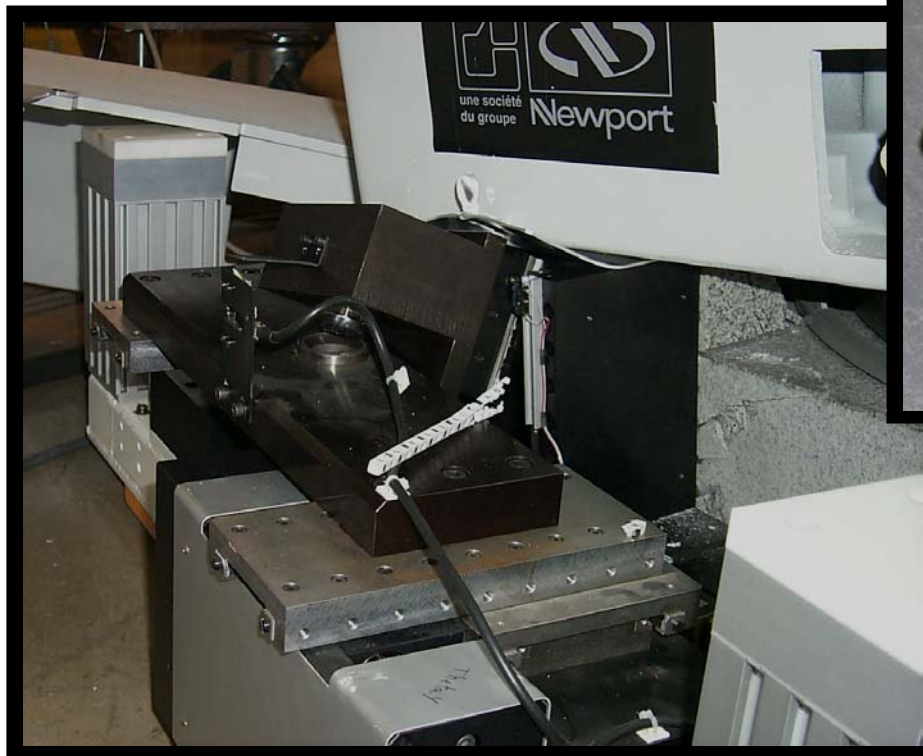
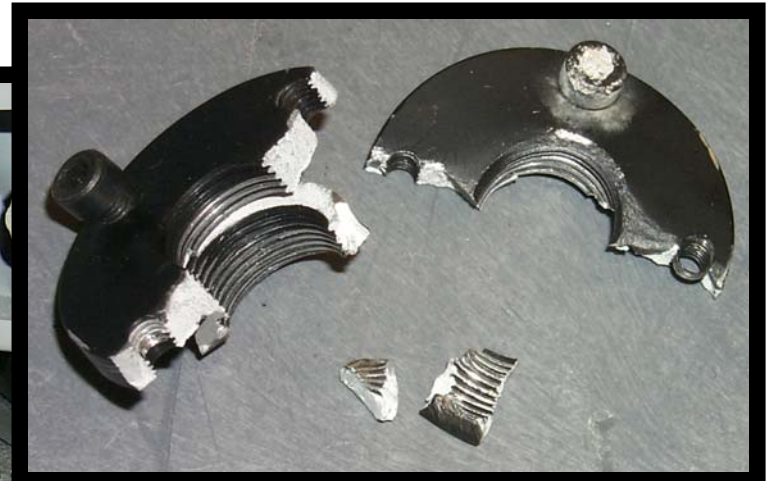
Reminder of the source of damage:

Y1 jack failed & diffractometer fell. Fundamental problem was weak retaining nut, which split in two (in addition to issue of cross-roller bearing cage migration).

- Repair damage to base
 - return to original condition at Newport's expense
- Redesigned jack, using rail & carriage for slides with recirculating balls
 - we pay for this (roughly at cost)
 - available for other kappa instruments at APS
- Thick safety plate on top of slide (just in case)
- Thicker, better-secured retaining nut

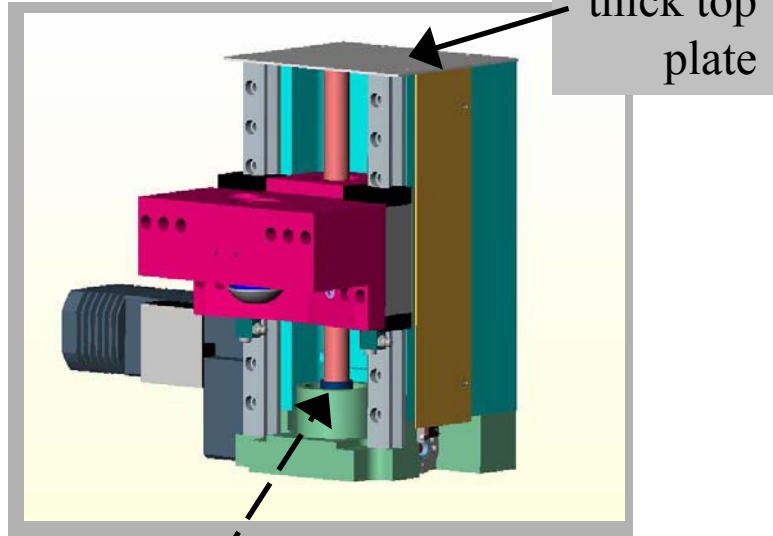
front view

Improved slides

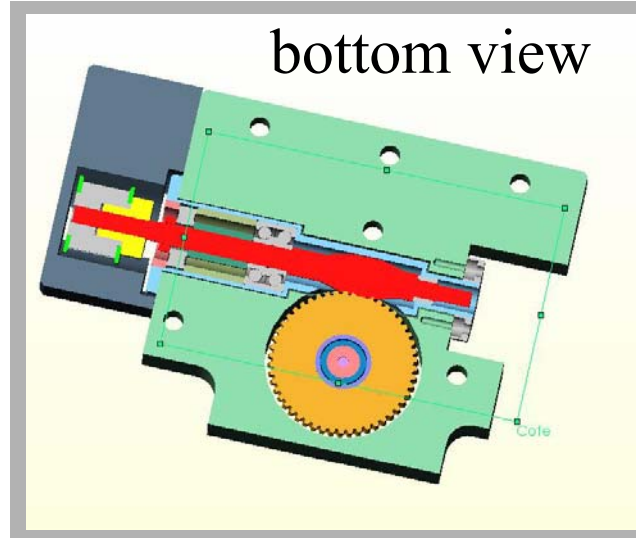
bottom view

thick top plate

new retaining
nut: steel,
11mm thick,
now held with
three screws

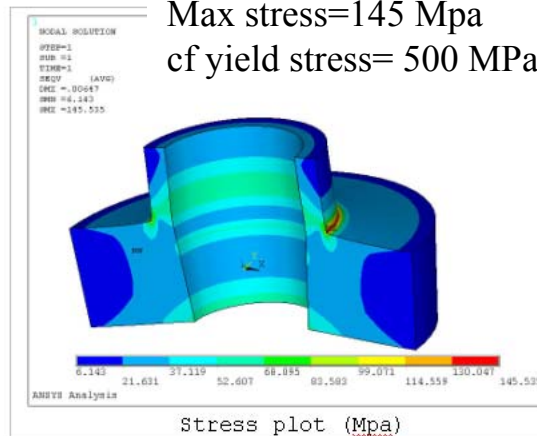
Max stress=145 Mpa
cf yield stress= 500 MPa

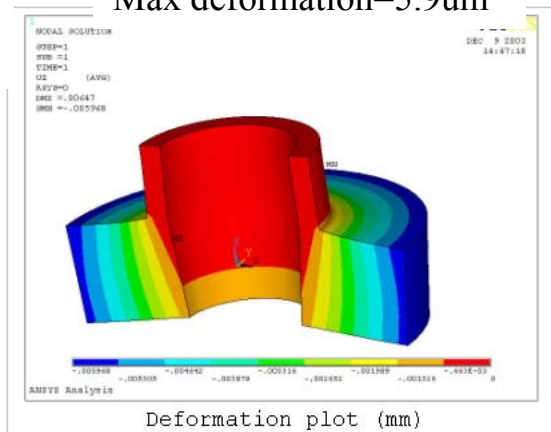
Max deformation=5.9um
